WRDC-TR-90-3078

**AN EXPERIMENTAL EVALUATION OF THE IMPACT RESISTANCE OF
RECOATED F-16A MONOLITHIC POLYCARBONATE FLAT SHEET**

Michael P. Bouchard
University of Dayton Research Institute
Dayton, Ohio 45469-0110

Interim Report for Period October 1984-March 1989

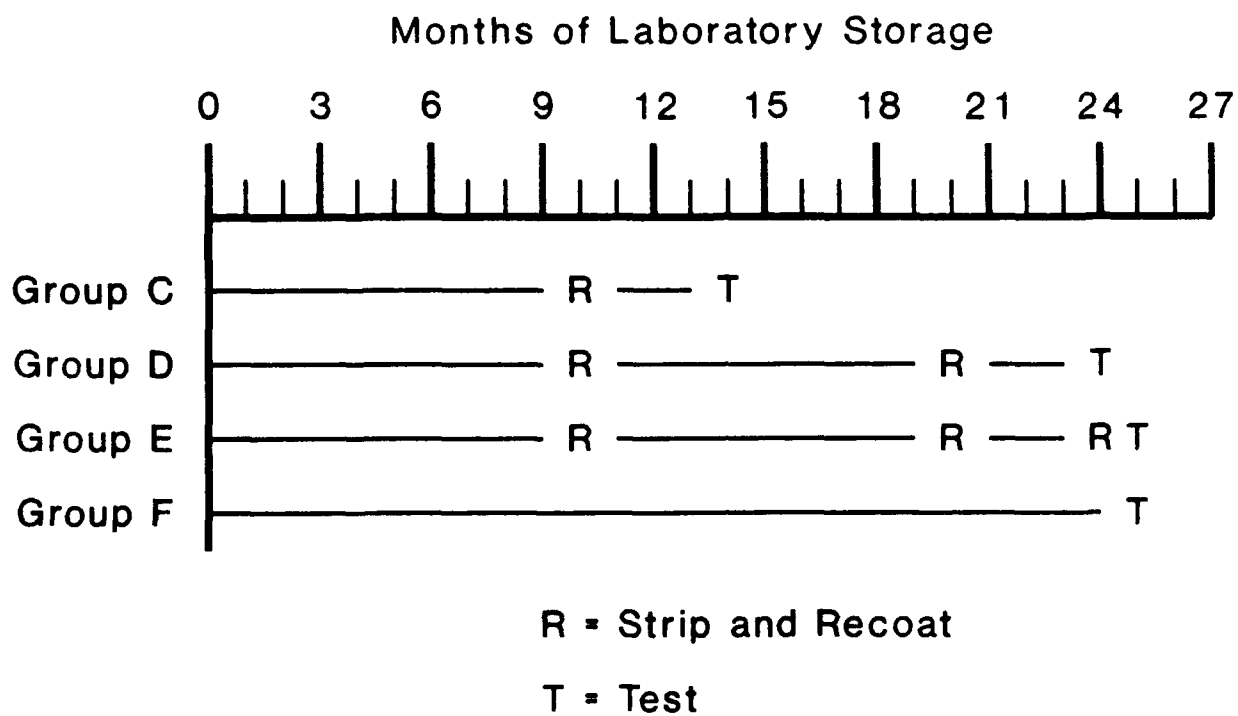
Figure 2.6. Schedule for Specimens Stored in Laboratory.

Specimen pretest conditioning consisted of laboratory storage and QUV weathering. For laboratory storage, the flat sheet material for specimen groups C-F was placed on edge in a box with a thin layer of packaging foam separating adjacent sheets to prevent scratching. The box was stored in a laboratory maintained at $73\pm 4^{\circ}\text{F}$ and $50\pm 5\%$ relative humidity. Figure 2.6 summarizes the laboratory storage schedule for each specimen group.

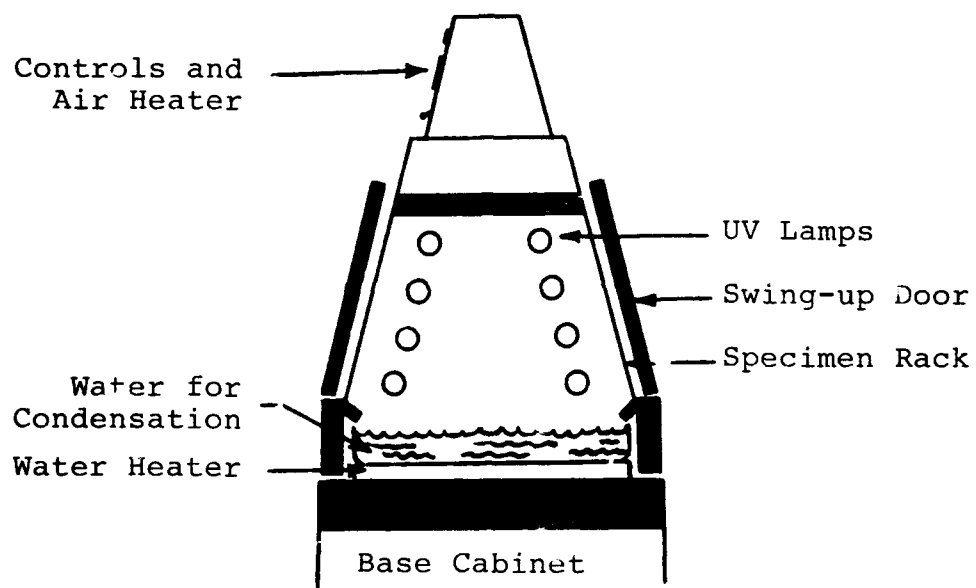
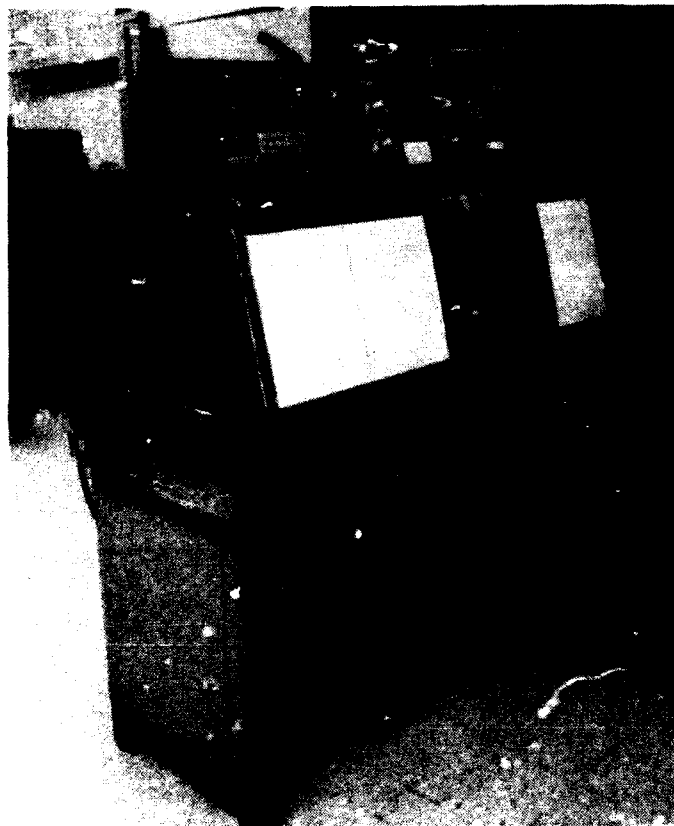
Figure 2.7. QUV Weathering Apparatus.

Artificial weathering of the specimens for groups G-M was accomplished using the QUV apparatus shown in Figure 2.7. The apparatus, which was manufactured by the Q-Panel Company of Cleveland, Ohio, consists of two banks of four fluorescent bulbs each, aligned parallel to two specimen racks. Closing in the underside of the unit is a shallow pan and water heater. The controls and air heater are located on top of the unit. Specimens are mounted such that their clearance from the bulbs is 2 inches. The bulbs are Q-Panel 48-inch fluorescent UVB-313, providing UV-B radiation with maximum output at 313 nanometers and a minimum output at 280 nanometers (1% of peak output).

Functionally, the QUV tester provides continuous output of heat with alternating UV radiation and condensation. A cycle timer adjusts the starting and ending times for the condensation and ultraviolet conditionings. The timer was set for 7 hours of radiation

followed by 5 hours of condensation. This cycle was repeated as needed to fill the required total exposure duration. One equivalent year of QUV weathering was 192 hours of exposure (including both radiation and condensation hours). The cycle and exposure times had been computed under previous test programs based on weather data for Phoenix, Arizona.^{8,9,10} The temperature during the entire exposure was $120 \pm 10^\circ\text{F}$.

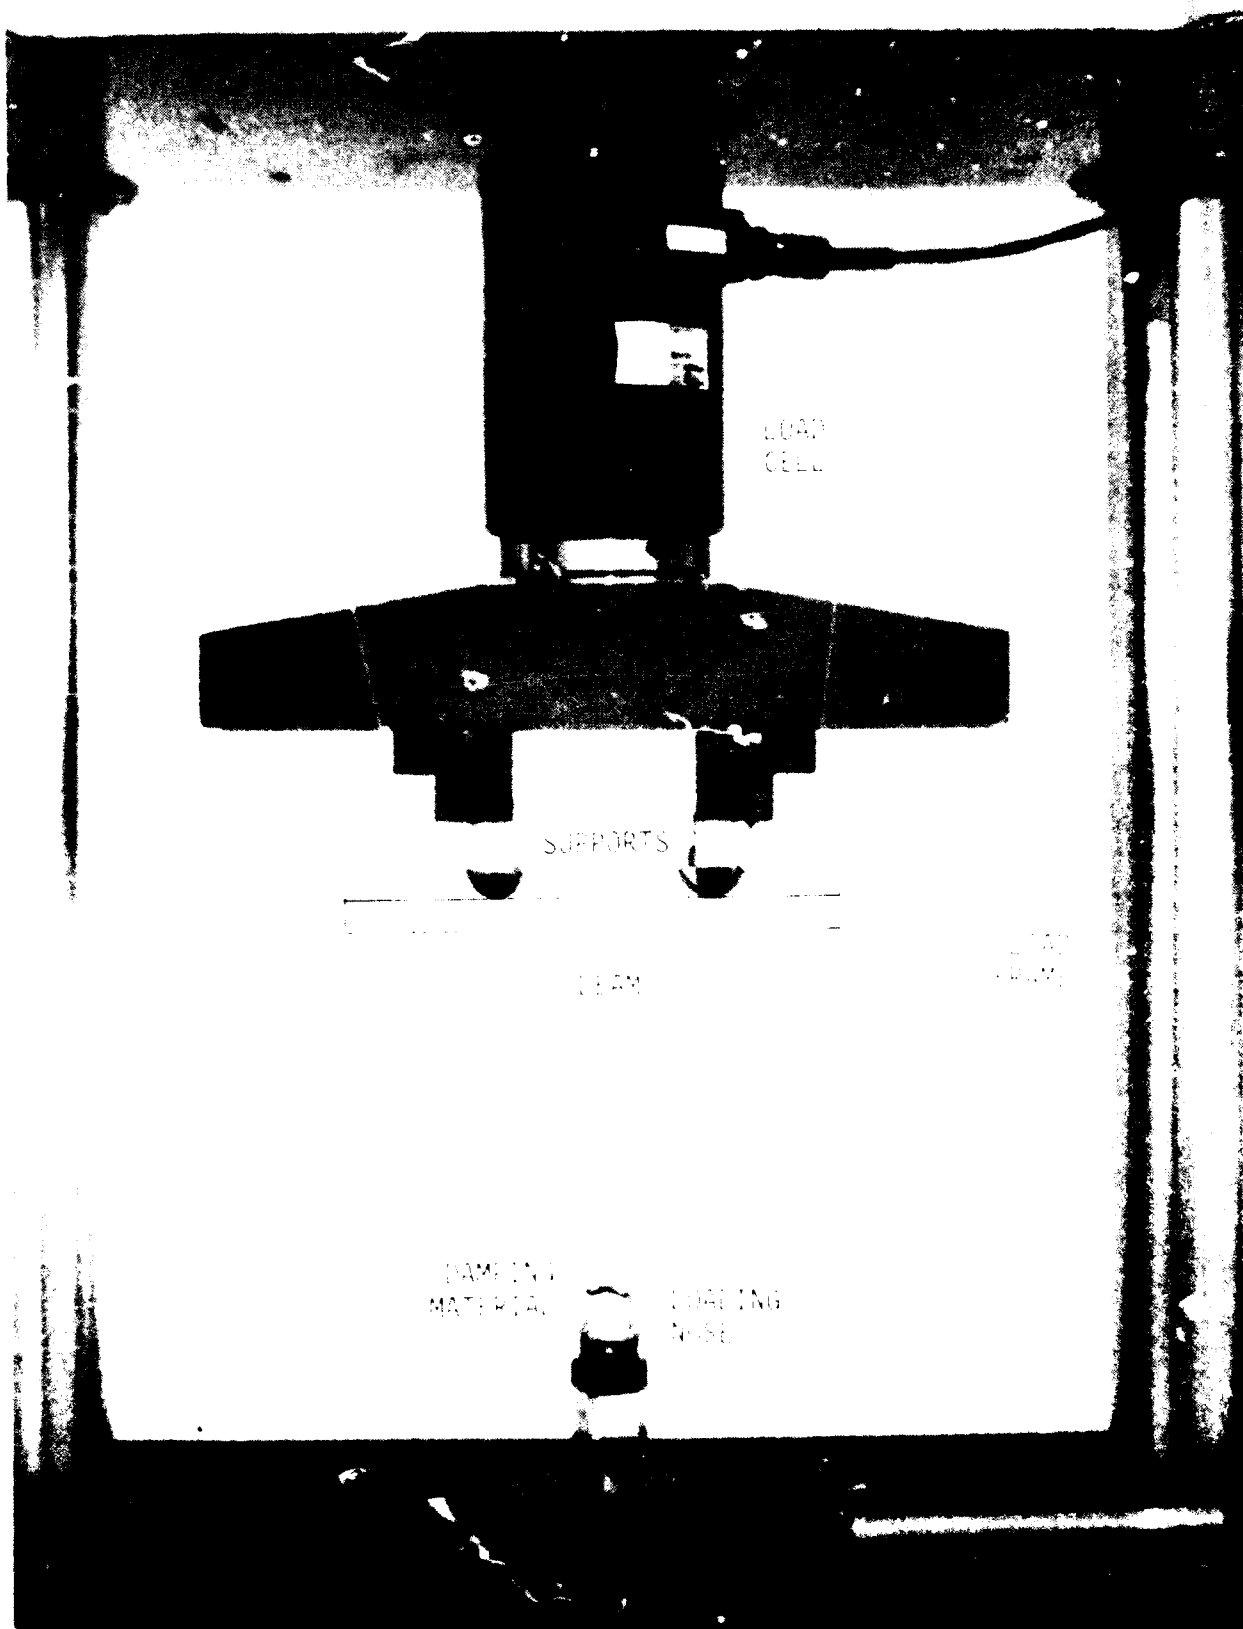
FIGURE 1. MOUNTING OF TEST APPARATUS

All MTS beams were loaded in three-point bending with the conditioned surface in tension using a nominal 4.5-inch span in accordance with ASTM Method F736-81⁶ and 0.75-inch-diameter supports and loading nose. The relatively short span specified in the falling weight method was chosen for the MTS tests to ensure that results could be correlated with falling weight tests (Section 2.5) and because a long span allows the highly ductile polycarbonate to push through the supports without failure (fracture). A high performance, high rate, open loop test system that included an axial load frame, load cell, displacement transducer, compressed nitrogen drive unit, and computer controller/recorder, manufactured by MTS Systems Corporation, was used for all testing. Figure 2.8 shows the test setup.

From Figure 2.8, it is apparent that the loading nose was not in contact with the specimen at the beginning of each test. Instead, it was located approximately 7 inches

from the specimen to allow it to attain the desired deflection rate (loading velocity) of 40,000 in/min. Note that since the system was operated in open loop (no feedback control) configuration, this loading rate was not maintained during test, but decreased after loading nose impact. The open loop configuration was used because the high strain rates desired could not be obtained using the slower, closed loop configuration. The 40,000 in/min deflection rate resulted in a calculated initial strain rate in the beam of nearly 150 in/in/sec, characteristic of expected transparency strain rates during impact (UDRI has computed strain rates of 100-450 in/in/sec from a limited number of high-speed films of birdstrike tests on T-38 and F-111 windshields). Appendix A of Reference 2 details the strain rate calculation for beams subjected to three-point bending. The maximum displacement of the loading nose after impact with the specimen was limited to 3.5 inches, excluding any compression of the load nose pads and necking/compression of the specimen. A computer stored load and displacement data generated by transducers mounted in the loading nose assembly. Graphs of load versus displacement were obtained subsequent to testing by sending the data from the computer to an X-Y pen plotter. Based on earlier studies,² strong transient vibrations caused by the shock of loading nose impact were damped by wrapping Cabot Corporation's C1002-12 damping material around the loading nose and the supports. The thicknesses were 0.25 inch for the loading nose wrap and 0.125 inch for the support wrap.

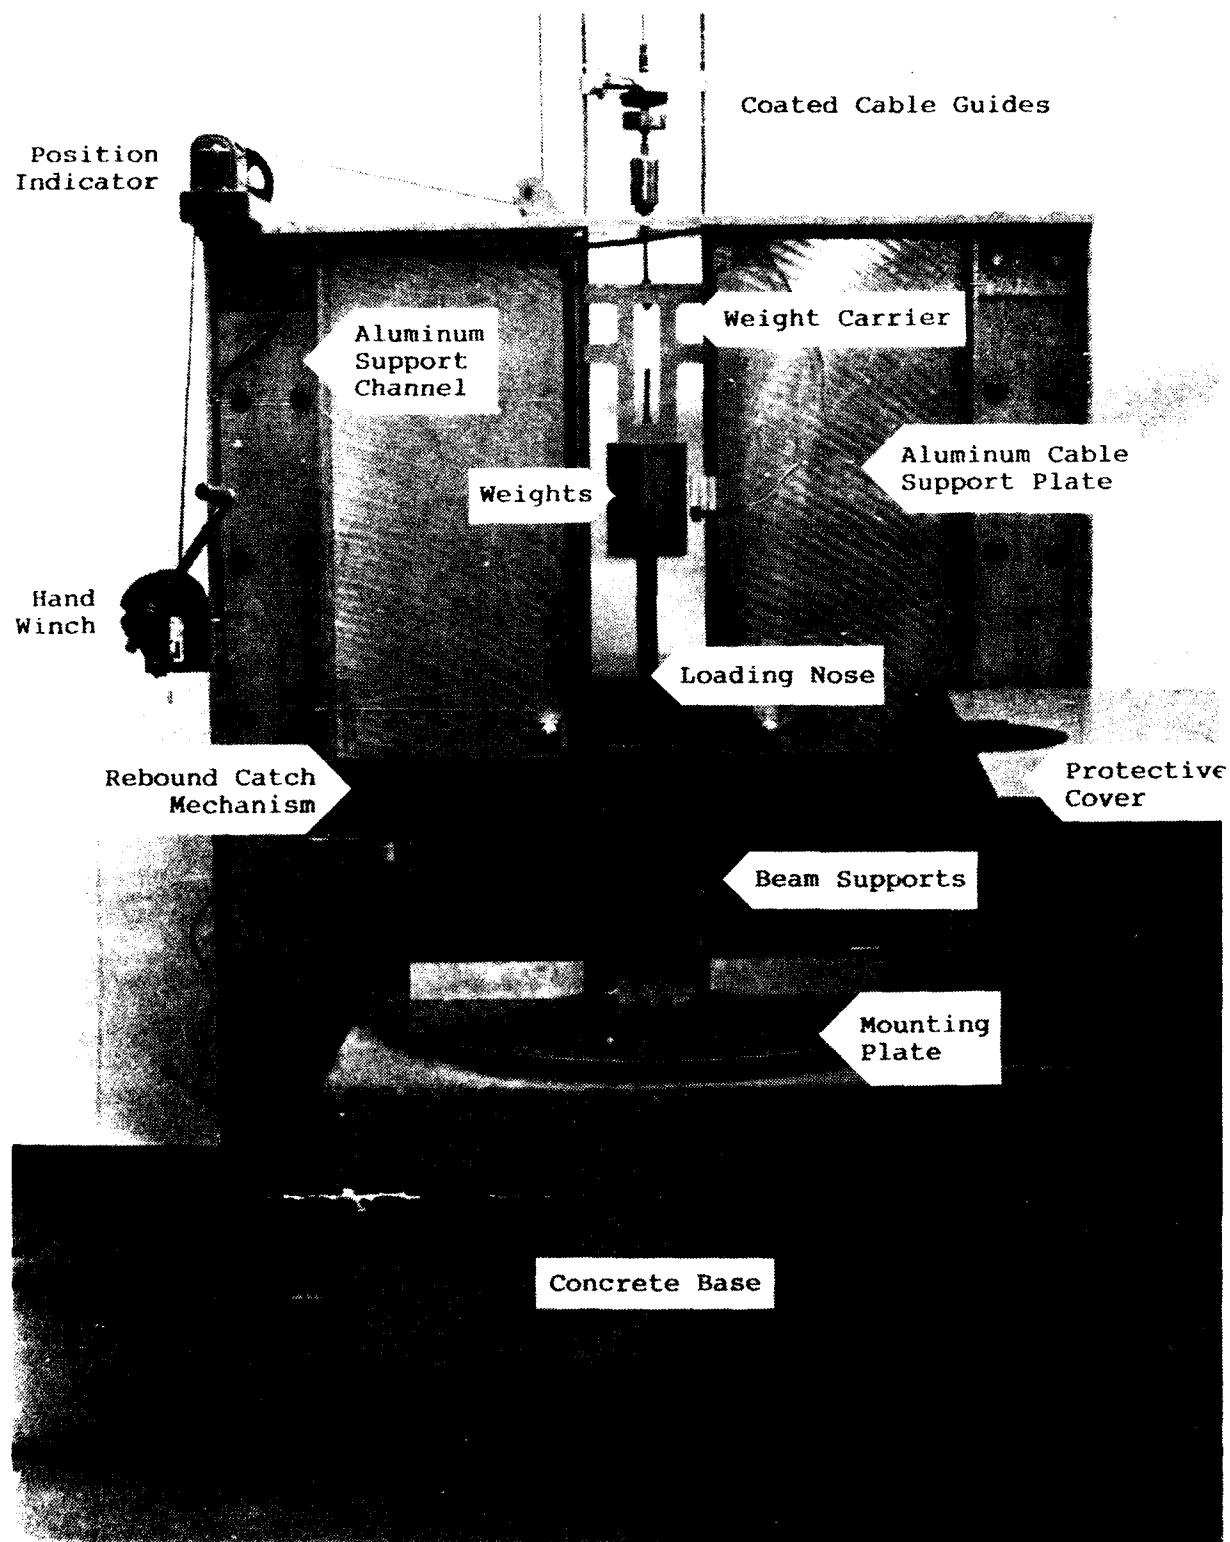
Figure 2.9. Falling Weight Test Apparatus.

Figure 2.9 shows the UDRI Falling Weight Impact Test Apparatus used for the testing. It consisted of a supporting frame and concrete base; adjustable-span reaction

supports; loading nose; detachable, interchangeable, and variable-mass drop weights; a two-cable system to guide the falling weight to the center of the specimen at a velocity approaching free fall; automatic release mechanism; and rebound catch mechanism.

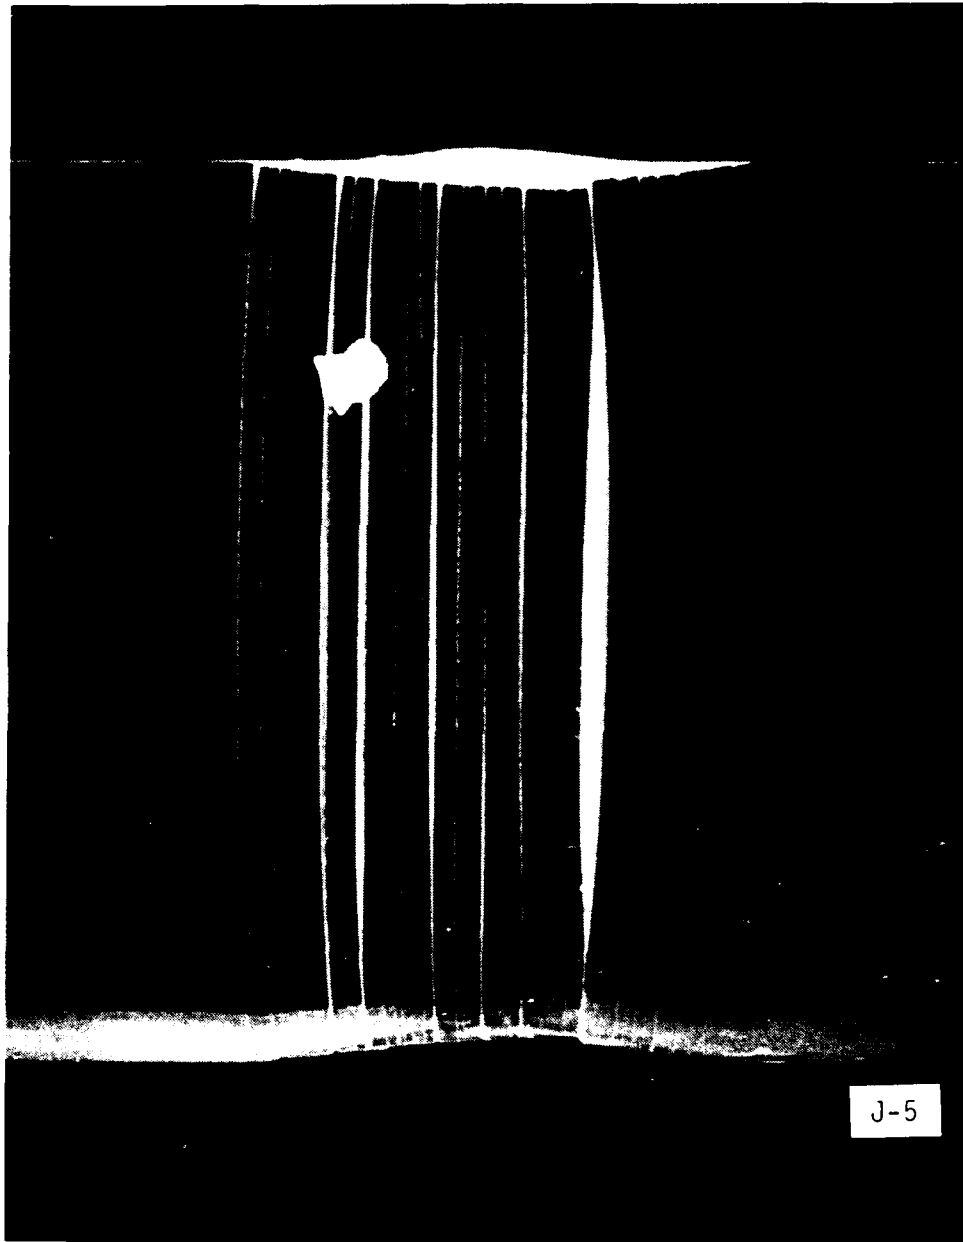
Figure 2.10. Threshold of Failure Cracking.

The desired failure mode was a visible open crack on the tension surface of the specimen, as shown in Figure 2.10. The drop weight and height were varied from their initial values until this failure mode was achieved. The remaining specimens were then tested at the revised weight and height values to verify the threshold-of-failure energy.

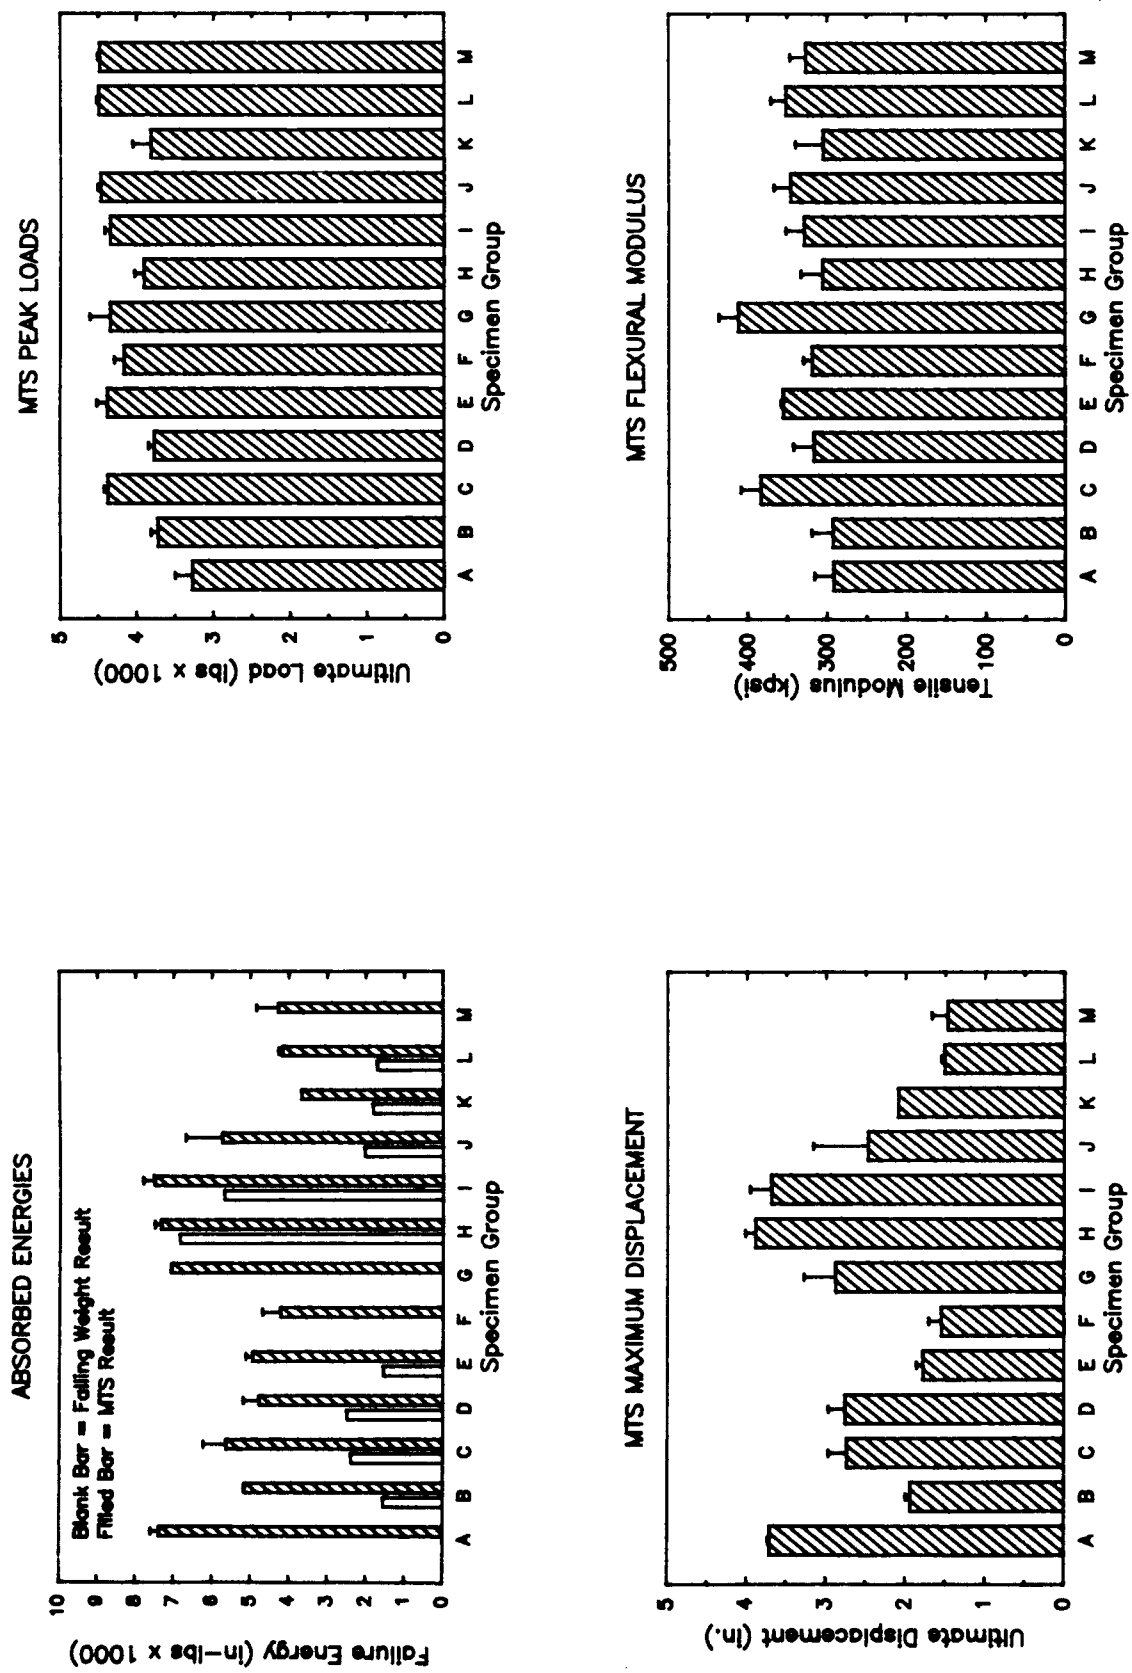
Figure 3.2. (Re)Coated F-16A Monolithic Polycarbonate Flat Sheet Beam Test Results.

From Figure 3.2, the absorbed energy and maximum displacement show significant variation from one group to another, indicating that these quantities were sensitive to the various means of pretest conditioning that were employed. On the other hand, the peak load and flexural modulus show relatively little sensitivity to changes in pretest conditioning. Because of these trends, absorbed energy and maximum displacement are the data of primary interest in the evaluation of the recoated material which follows.

From Figure 3.2, it is also evident that the falling weight absorbed energies were generally much less than the MTS absorbed energies. The difference was primarily due to the fact that two different energies were being computed. For the falling weight test, the energy being computed was the failure energy, which was the energy required to produce a visible open crack in the specimen tension surface. For the MTS test, the computed energy accounted for all energy absorbed, which included the failure energy and

any energy absorbed after initial cracking occurred. The results for groups H and I, which were exceptions to this general trend, are discussed in Section 3.3.

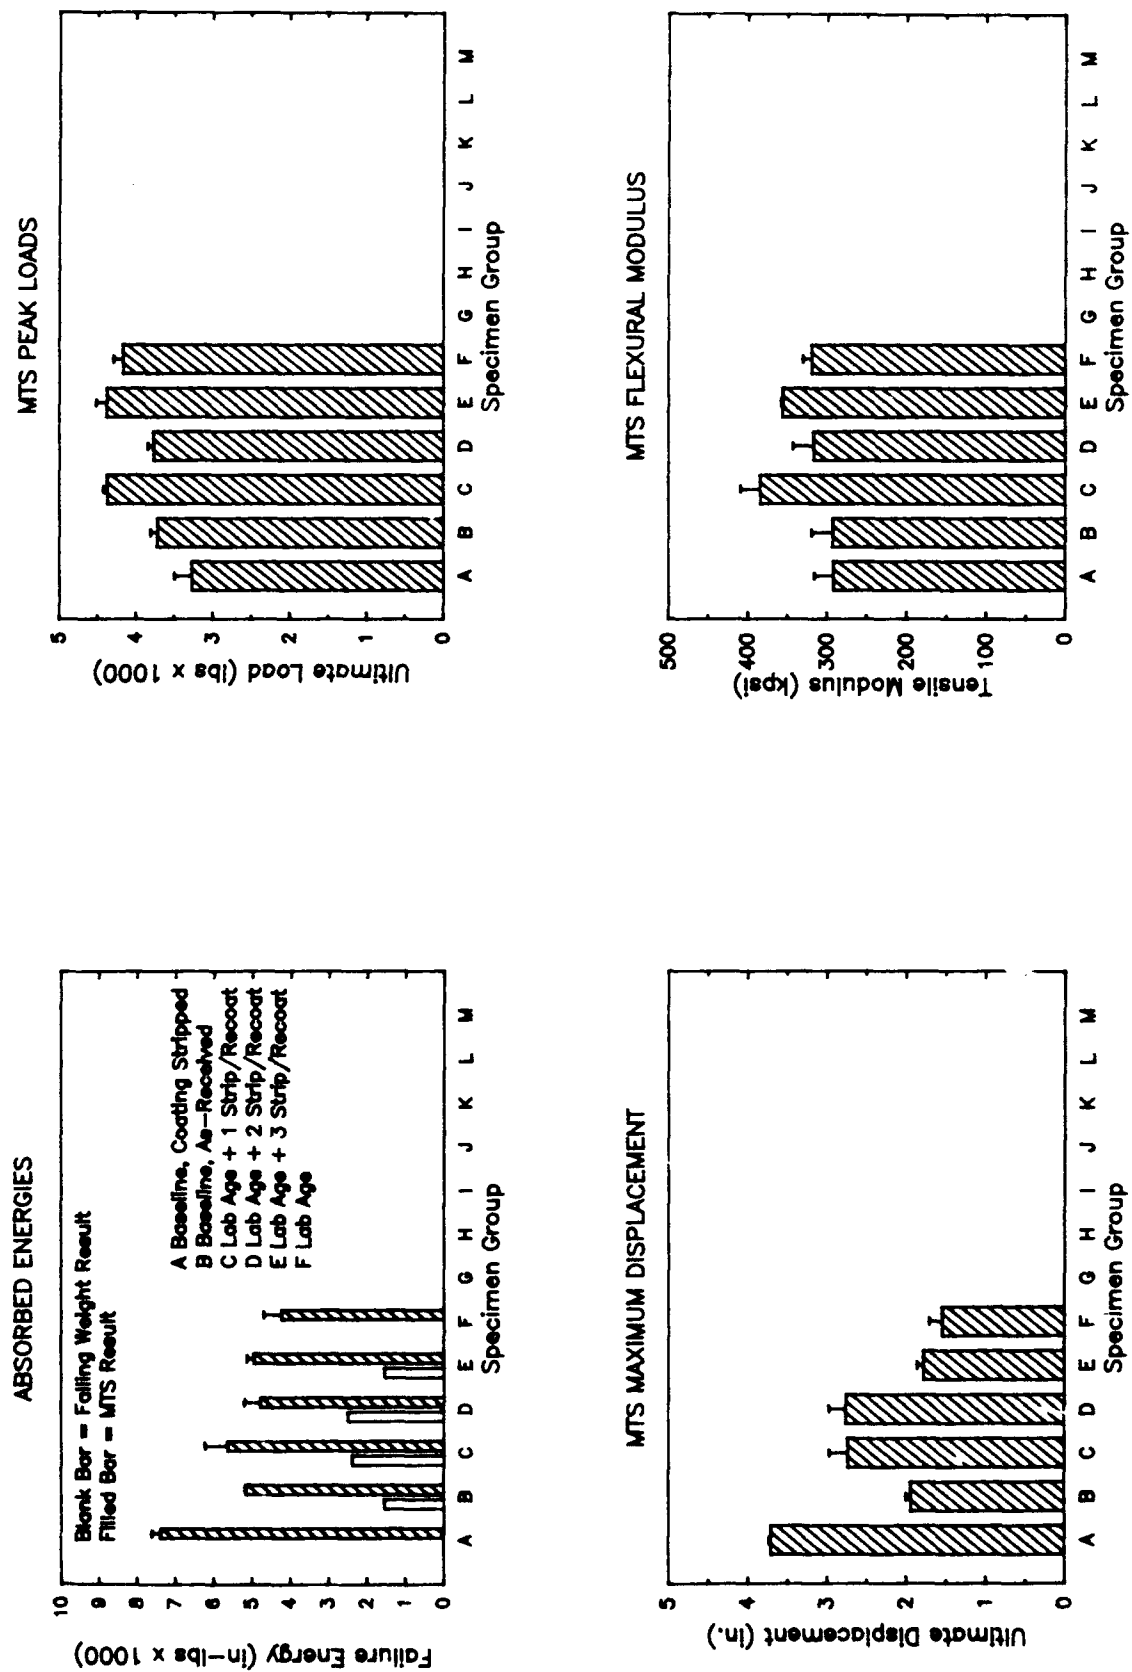
Figure 3.4. Flat Sheet Beam Test Results for Specimens Stored in Laboratory and Stripped/Recoated.

Figure 3.4 presents the average test results for those specimens subjected to laboratory storage and, for three cases, stripping and recoating. Also presented for comparison are the baseline results. Specimen group F, which retained its original coating and which received the longest storage time, 25 months, experienced no significant loss in impact resistance. The absorbed energy was similar to the coated baseline (Case B)

results while the maximum displacement was greater than or equal to the Case B results (but not up to the maximum displacement of the Case A stripped specimens). The results therefore indicate that 24 months storage in the controlled laboratory environment did not degrade the impact resistance of the coated polycarbonate sheet. The results also indicate that the stripping and recoating process, in conjunction with the laboratory storage, did not degrade the impact resistance, even for samples which were stripped and recoated three times.

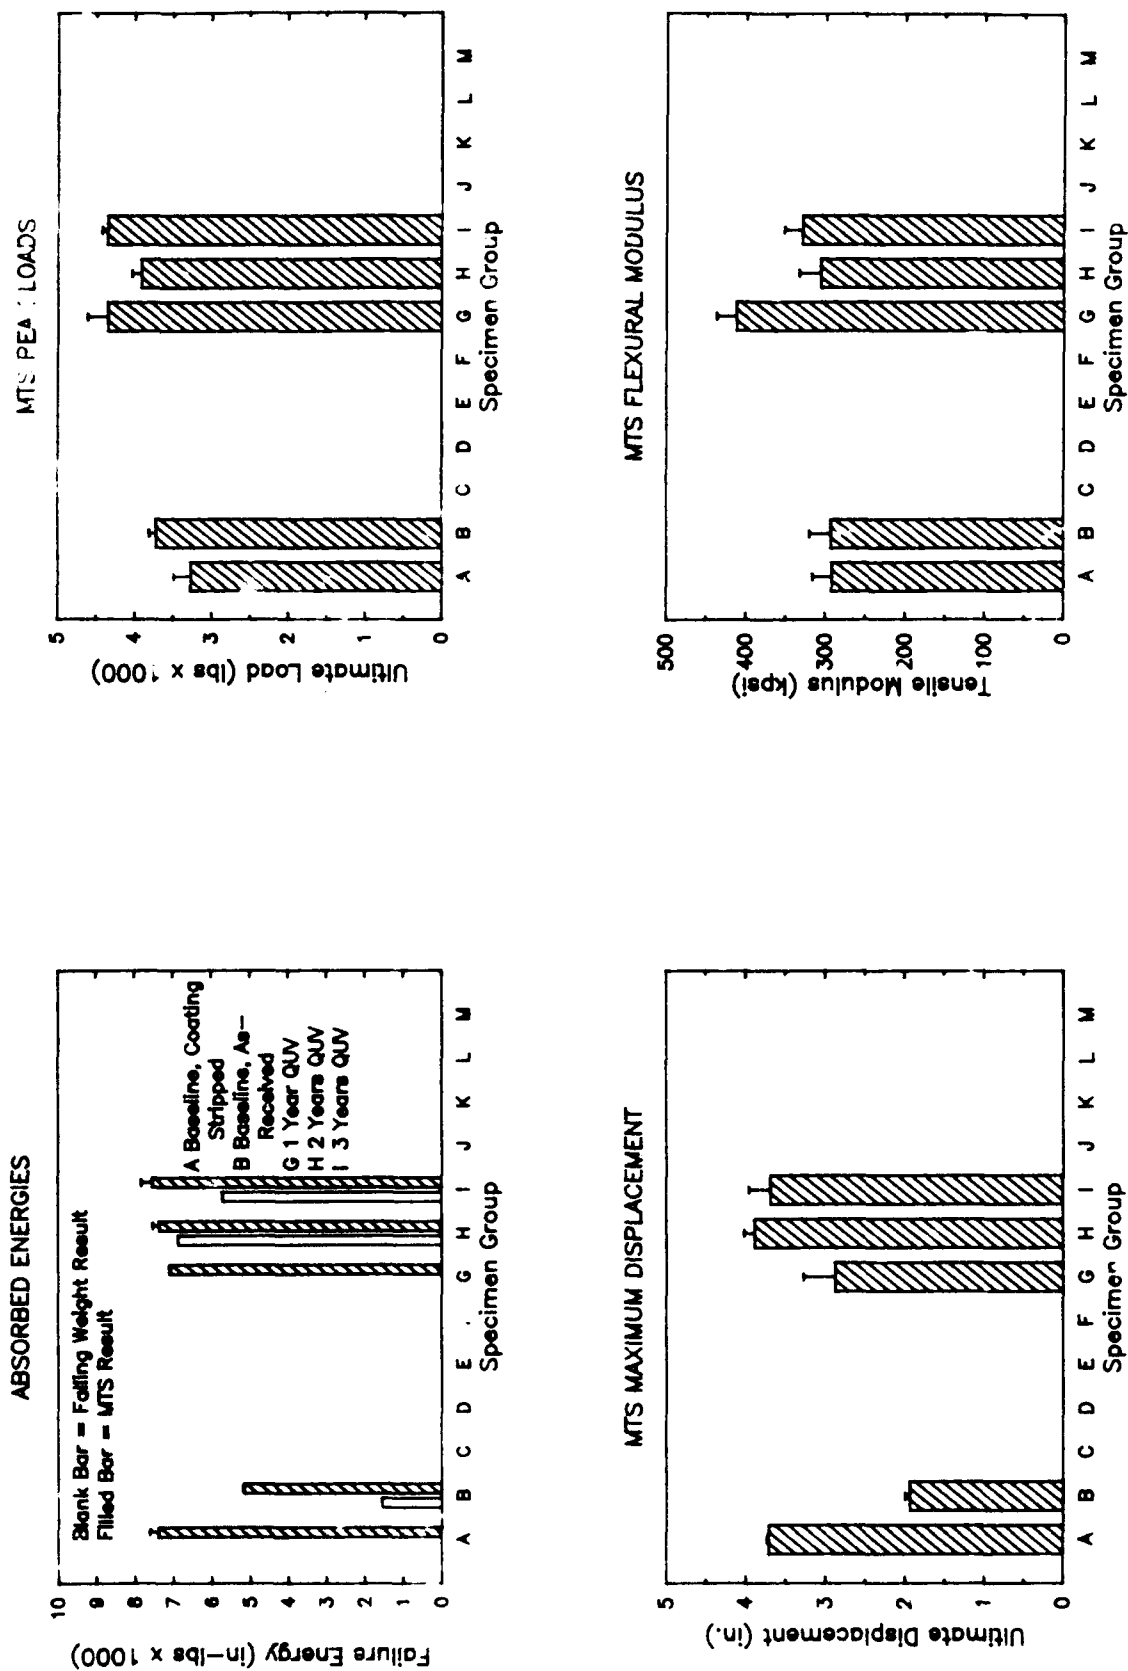
Figure 3.5. Flat Sheet Beam Test Results for Specimens Weathered in QUV.

Figure 3.5 presents the average test results for those specimens subjected to QUV weathering. Also presented for comparison are the baseline results. The absorbed energies and maximum displacements were similar to those for the stripped (Case A) baseline specimens even though all samples receiving QUV weathering were coated. The results show that the QUV weathering alleviated the embrittling effect of the coating, restoring the impact resistance of the coated polycarbonate to levels obtained by uncoated polycarbonate. (However, as discussed in Section 3.5, there was a significant decrease in coating adhesion owing to the QUV weathering.) Nearly all of the increase in absorbed energy was obtained in the first equivalent year of weathering, with only slight increases occurring thereafter. Note finally that the falling weight energies were approaching the values of the MTS energies. The specimens for these groups experienced extensive ductile deformation prior to cracking. Therefore little energy was absorbed after cracking, so that the falling weight and MTS energies nearly coincided. These same trends (in QUV effects on coated monolithic F-16A polycarbonate impact resistance and on MTS versus falling weight absorbed energies) have been noted in other studies conducted on F-16 coated monolithic polycarbonate material.^{2,10}

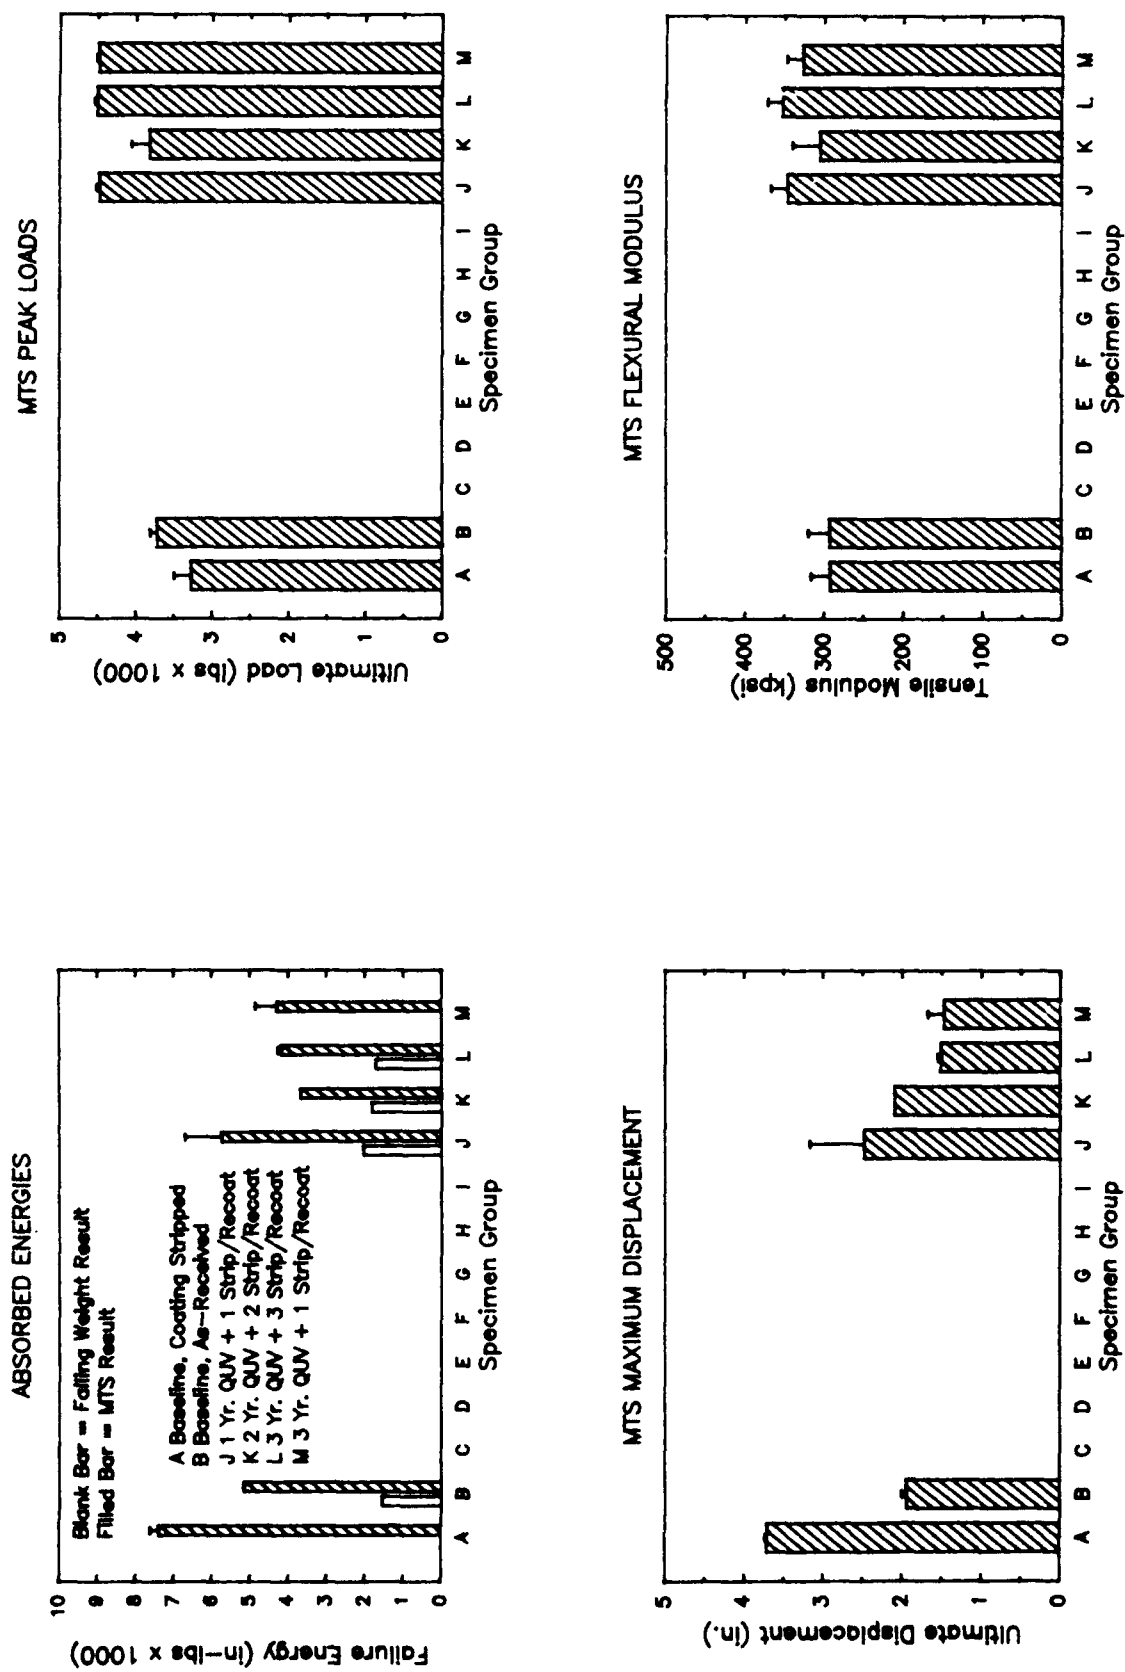
Figure 3.6. Flat Sheet Beam Test Results for Specimens Weathered in QUV and Stripped/Recoated.

Figure 3.6 presents the average test results for those specimens subjected to QUV weathering and subsequent stripping and recoating. Three groups (J, K, and L) were stripped and recoated after each equivalent year of QUV weathering while one group (M) was recoated after 3 equivalent years of QUV weathering. The MTS absorbed energy and maximum displacement data for groups J, K, and L show fairly significant differences, for unknown reasons. Even so, these data, along with the falling weight data, indicate that the impact resistances for these groups, and also for group M, were similar to the baseline coated impact resistance. Therefore there appears to have been no degradation of impact resistance because of the combined QUV weathering and stripping/recoating processing. Note that the increase in impact resistance because of QUV weathering discussed in Section 3.3 was not evident in the results for groups J, K, L, and M because stripping and recoating followed all weathering for these groups. The stripping and recoating process thus appears to have restored the weathered specimens to "like-new" condition from the standpoint of impact resistance.

Finally, there was no significant difference in impact resistance between the specimens which were stripped and recoated after each of 3 equivalent years (group L) and those which were stripped and recoated after completing 3 continuous equivalent years of QUV weathering (group M). Thus the accumulation of several strip and recoats did not degrade the impact resistance relative to either the baseline results or to the results for specimens receiving only a single strip and recoat. These results for multiple strips/recoats agree with those of Section 3.2.

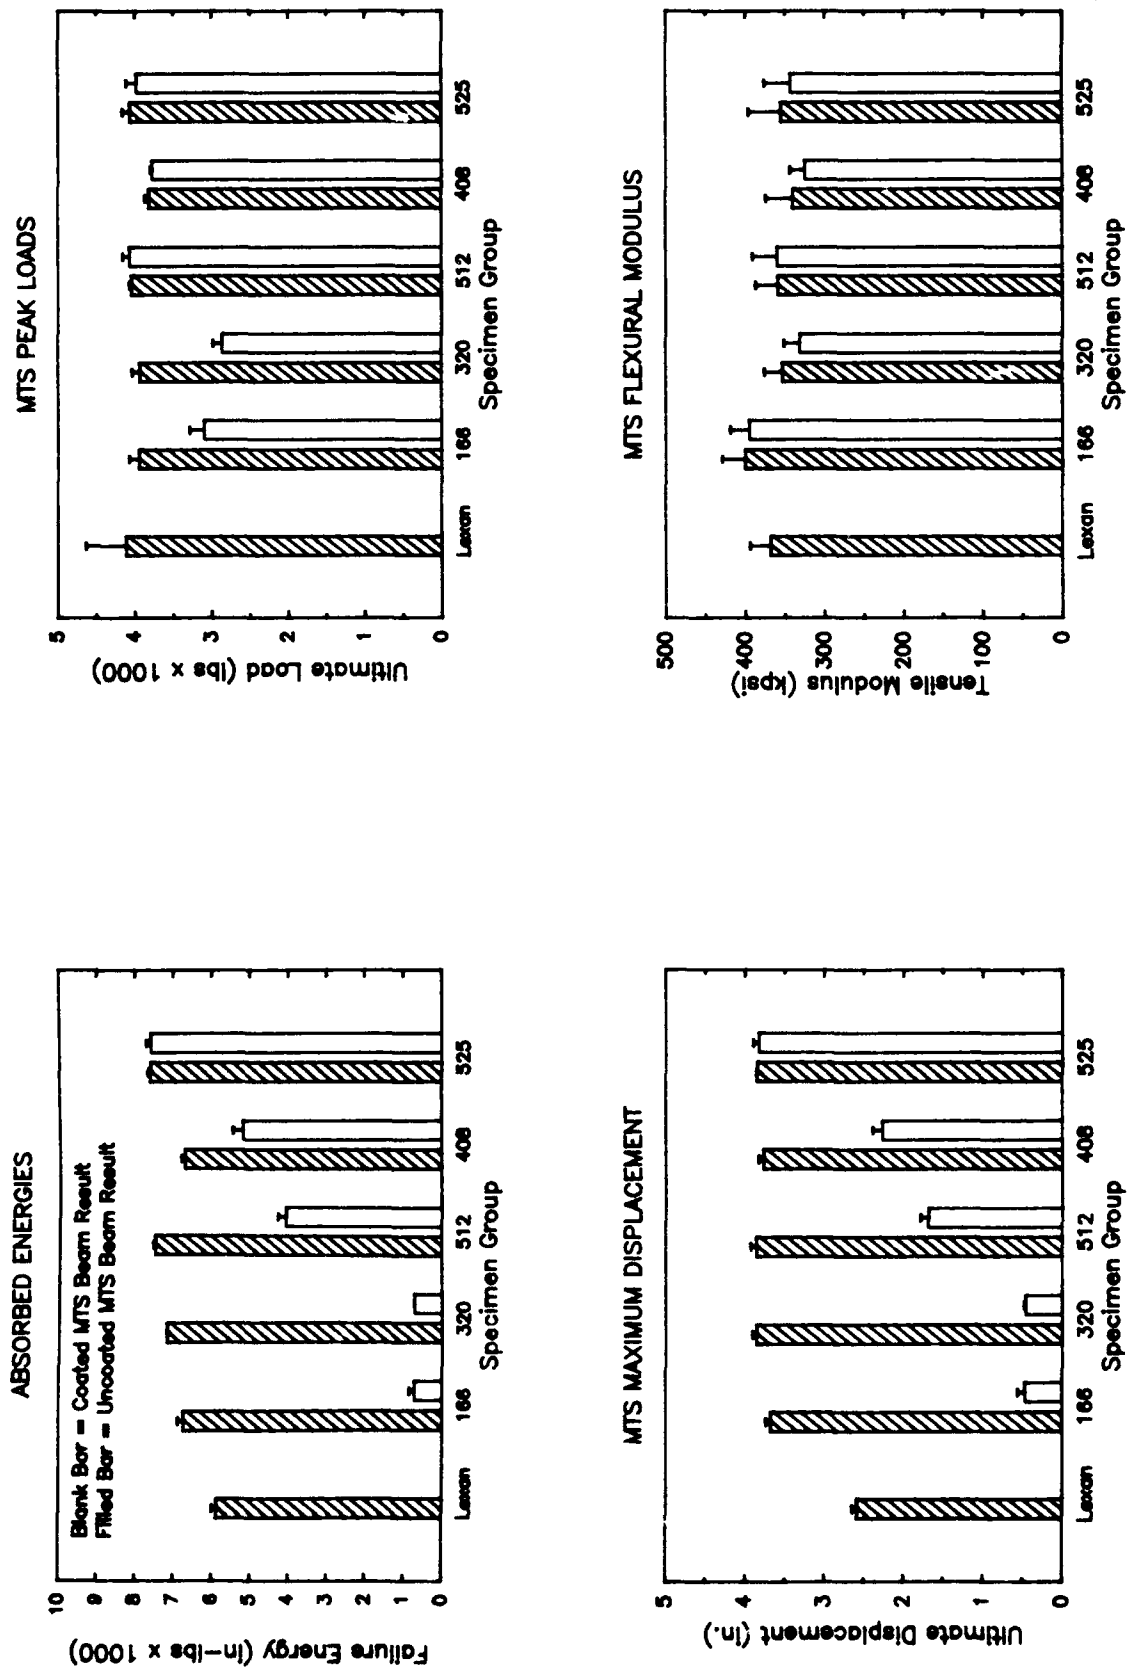
Figure 3.7. Recoated F-16A Monolithic Canopy Beam Test Results (Reference 2).

Reference 2 includes discussion of MTS and falling weight three-point beam tests performed on F-16A forward monolithic polycarbonate canopies that had been recoated and, in some cases, had been subjected to additional service life after recoating. Table 3.3 summarizes the recoated canopy specimen groups and service history. Commercially-available uncoated Lexan served as a baseline for these tests. Figure 3.7 presents a bar chart summary of the MTS test results. The results are directly comparable to Figures 3.2-3.6 since all test conditions were similar.

76% less (0.46 in versus 1.94 in). The small differences in specimen thickness and test span (10% at most) could not account for these sharp differences. The data appear to indicate that the differences were due to differences in the C-254 coatings that were applied to both the flat sheets and canopies. It is known that various formulations of the C-254 coating can be produced which can adjust the coating hardness. It appears that the flat sheet material received a softer coating formulation than the canopies. Despite the differences in the resulting data, the data trends for the flat sheet and canopy coated specimens were the same (i.e., absorbed energy and maximum displacement for uncoated/stripped material is greater than those of a newly coated material, and increasing weathering/service life duration results in increasing absorbed energy and maximum displacement).

The absorbed energy and maximum displacement for the coated canopy specimens show increasing impact resistance with increasing service life. The impact resistance reached the same level as the stripped canopy specimens for canopy 525 after 35 months of service life following the application of the initial coating. Note that for the flat sheet coated samples, the impact resistance reached levels comparable to the stripped specimens after only 1 equivalent year of QUV weathering. One equivalent year of QUV weathering was therefore possibly equivalent to 3 years of service life of canopy 525 in terms of achieving similar effects on impact resistance. (As discussed above, the flat sheet coating was apparently softer than that applied to the canopies, so that not as much coating degradation was required to reach impact resistance levels typical of uncoated material. Therefore it is possible that 1 equivalent year of QUV could equal less than 3 years of canopy 525 service life.) With respect to impact resistance of coated monolithic polycarbonate, the QUV cycle times and duration for 1 equivalent year of weathering may have been too severe to simulate the effects of 1 actual year of canopy service life. The severe effects of QUV weathering on impact and craze resistance have been noted in previous studies.^{9,10}

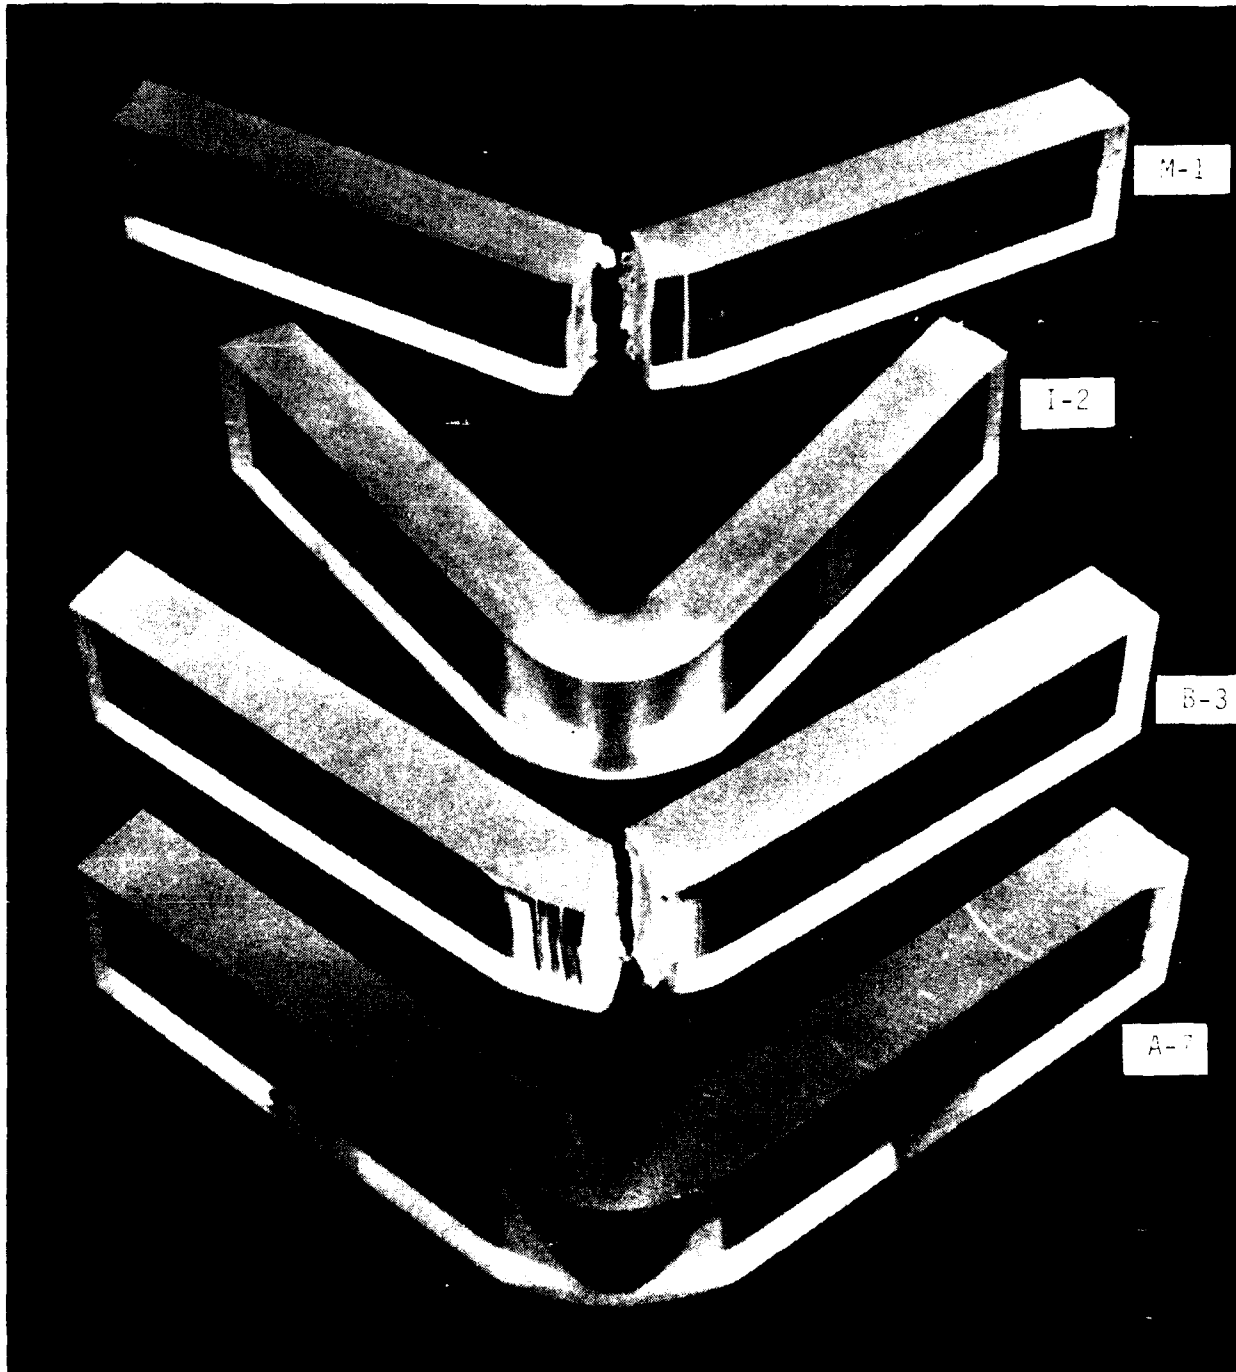
Figure 3.8. Typical Failure Modes for the Flat Sheet Beams.

Figures 3.8 and 3.9 present failure modes for the flat sheet and canopy beams, respectively. The baseline stripped (B) and Lexan (L) baseline beams showed excellent ductile deformation, although the Lexan beams cracked deeply for unknown reasons. The newly coated (A) and recoated (M and 166) beams showed little permanent deformation prior to fracture into two pieces. The beams with the original coating and subsequent QUV weathering (I) or service life (525) showed excellent ductile deformation. All of the QUV beams (G, H, and I) showed excellent ductility, although the G beams all fractured into two pieces, two of the H beams fractured into two pieces, and only one of the I beams fractured into two pieces. None of the canopy 525 beams fractured into two pieces. Yield lines in the coatings of the flat sheet and canopy beams were similar. The newly coated beams had coarsely-spaced transverse yield lines which penetrated deep into the polycarbonate substrate as a result of testing. With increasing service life or QUV weathering, the lines became more closely spaced and shallow, giving a hazy appearance to the test surface. For the 2 and 3-year flat-sheet beams with the original coating and QUV weathering (H and I) and the canopy beams with the original coating and service life (525), the coating adhesion was reduced significantly, so that the yield lines did not penetrate the polycarbonate substrate and the coating was easily removed by scratching by a fingernail. In summary, the failure modes of both the flat sheet and canopy beams (1) compared favorably, (2) indicated that increasing QUV weathering or service life resulted in increased ductile deformation during testing, and (3) indicated reduced coating adhesion with increasing QUV weathering or service life.
